Risk factors at level crossings with flashing lights in the Czech Republic

Pavλίna Skládaná, Pavel Skládaný, Pavel
Tučka, Jiří Ambros

Centrum dopravního výzkumu, v. v. i.

SAFER LC, Madrid, October 2018
Risk factors at level crossings with flashing lights in the CR

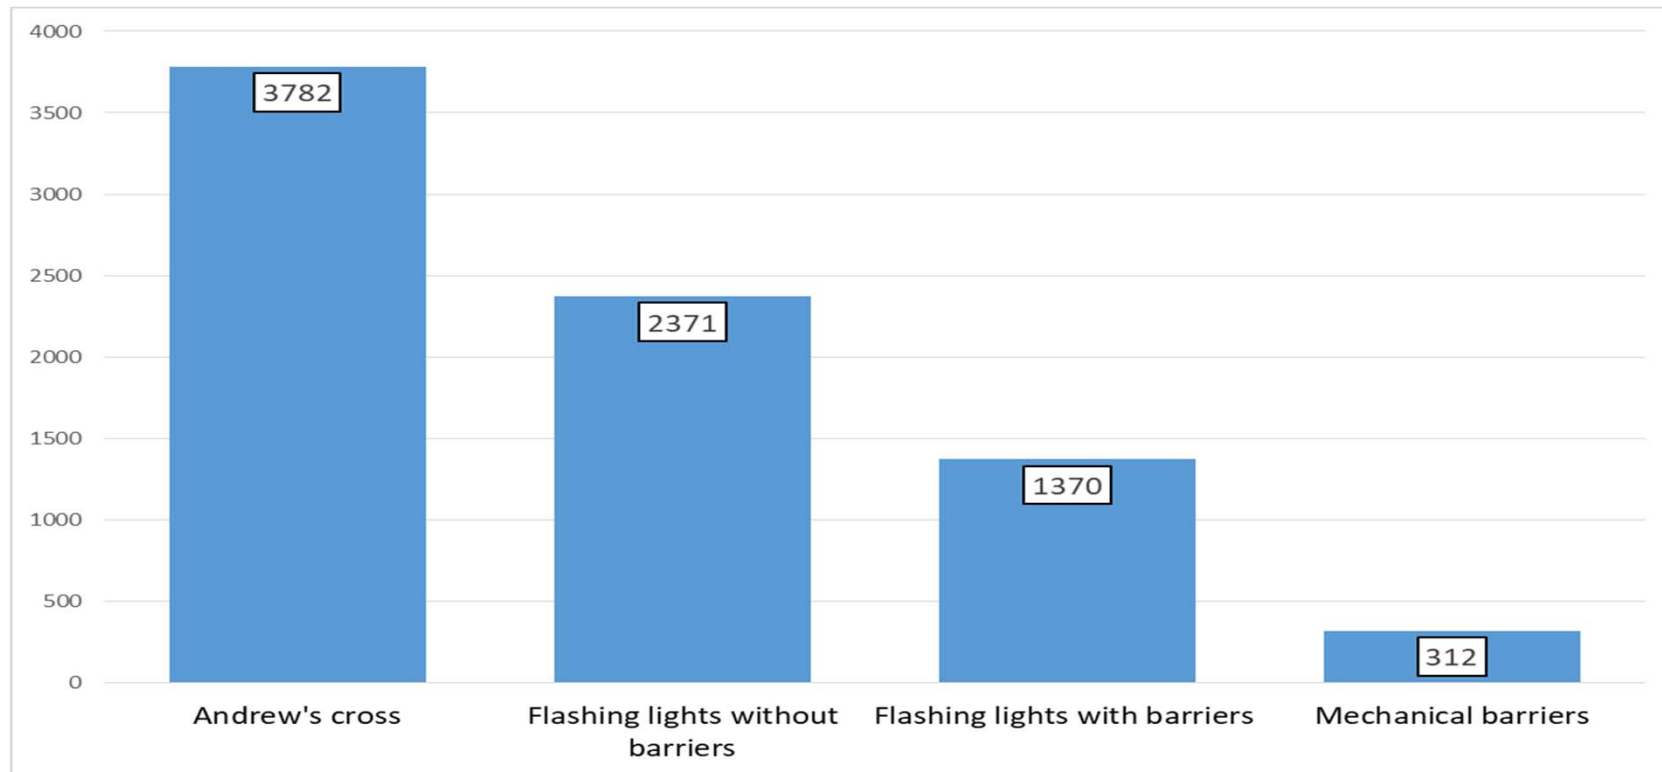
Level crossings and accidents in the CR

Data 2017: 7870 registered level crossings, of which 3782 with Andrew's cross; **2371 with lights**; 1370 with lights and barriers, 312 with mechanical barriers, 35 other (source: SŽDC).

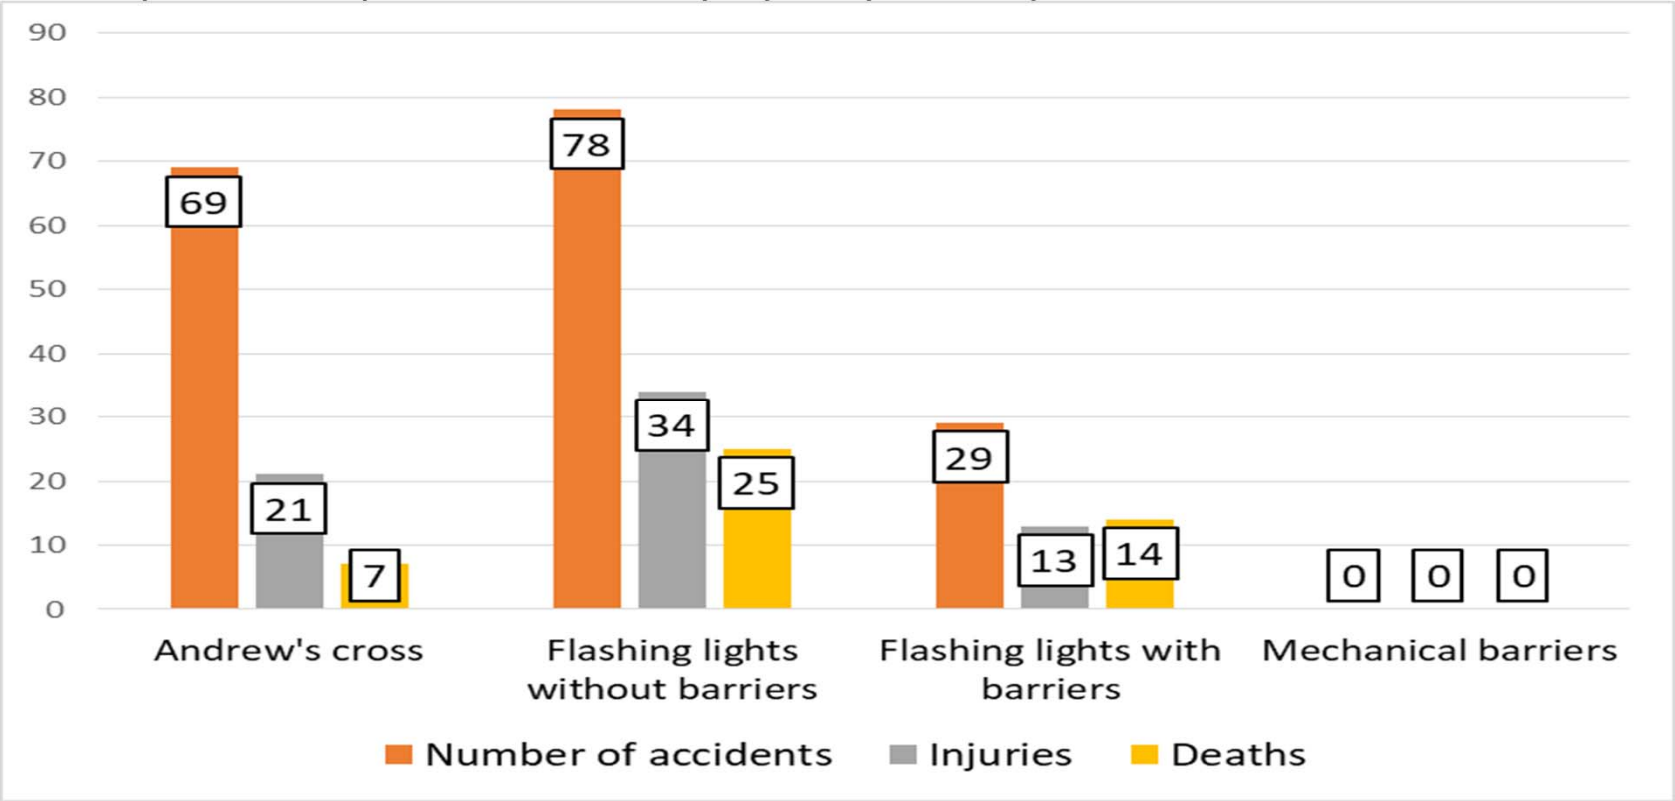
Number of accidents and casualties is the highest (both absolutely and relatively) at level crossings with flashing lights without barriers.

Example 2016 (source: Rail Safety Inspection):

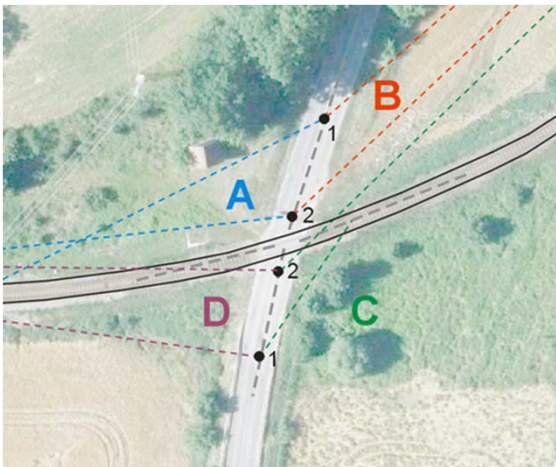
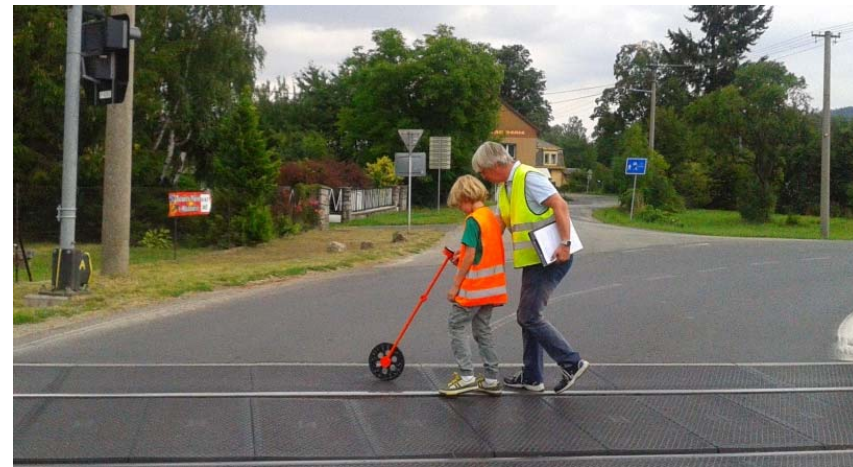
Train volumes and speeds were provided by Railway Infrastructure Administration, other data was collected from maps and in the field:

- observing current state of RLC infrastructure, flashing lights, road marking and signing, etc.
- taking photographs to enable later checks of observations and measurements
- collecting road vehicles' volumes and speeds by roadside radars
- measuring sight distances by digital distance meter in each quadrant

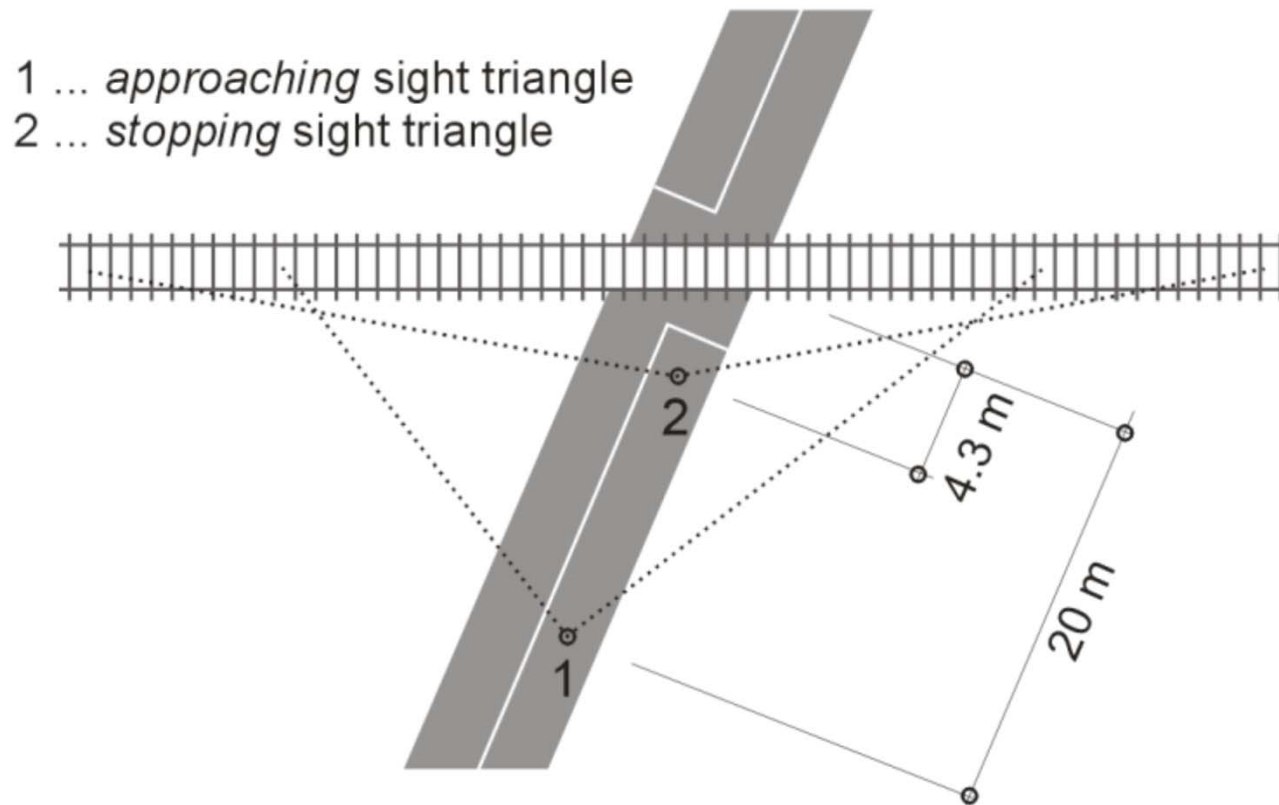
Sight distances were assessed from two positions in each quadrant.

Approaching and stopping sight distances proved to have opposite impacts at level crossings with flashing lights.

- Long approaching sight distance contributes to safety; together with warning lights, good sight enables „double control“ and driver can see approaching train even in situation when warning lights are difficultly visible or perceptible (strong sunlight, light disguised by other vehicle).
- Long stopping sight distance appears to be less useful; good sight from this point may take driver's attention away from warning lights, that are in this moment crucial.

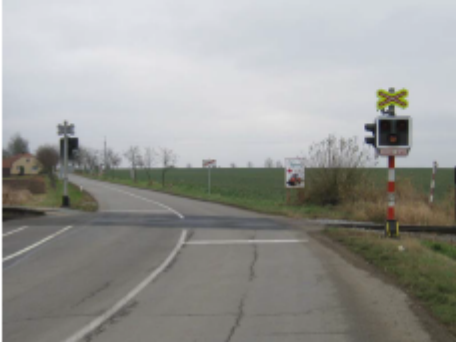
P6967	Klnice u Boskovic

Příklad přehledu výstupů z radarového měření:

49° 32' 06.48138" N 16° 41' 20.71277" E km 21,131 (Skalice n/Sv. – Chornice) x silnice II/374		
Měřeno dne: 28. 11. 2016			
Silniční doprava			
	Osobní vozidla	Nákladní vozidla	Celkem
Intenzita přepočtená na RPD	5288	525	5813
85. percentil rychlosti	52	48	
Překračování rychlosti 30 km/h			94,0 %
40 km/h			61,9 %
50 km/h			16,7 %
60 km/h			1,2 %
Drážní doprava			
Intenzita	6		
Průměrná rychlost	34		
Nejvyšší traťová rychlost	50

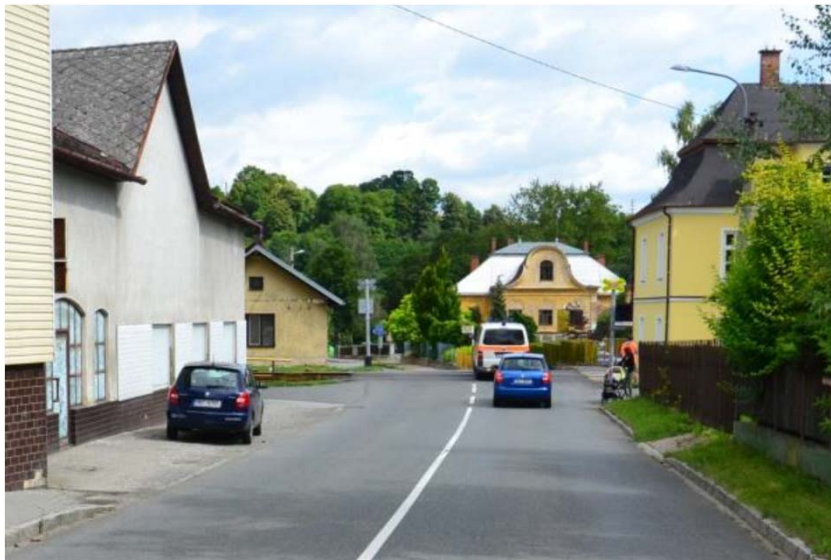
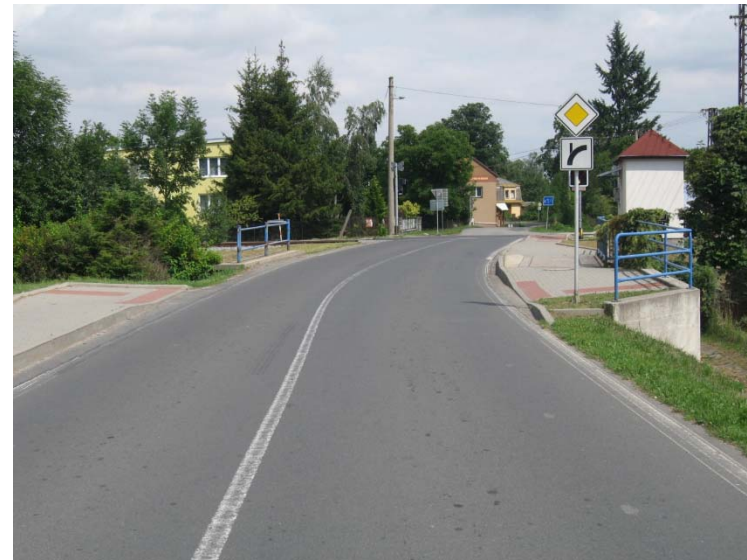
Observability of the level crossing proved to be very important factor. Inconspicuous or even invisible crossing makes driver's perception of the situation difficult, and missing road marking that should highlight the boundary of the crossing makes it difficult for users to decide where optimal stopping point is.

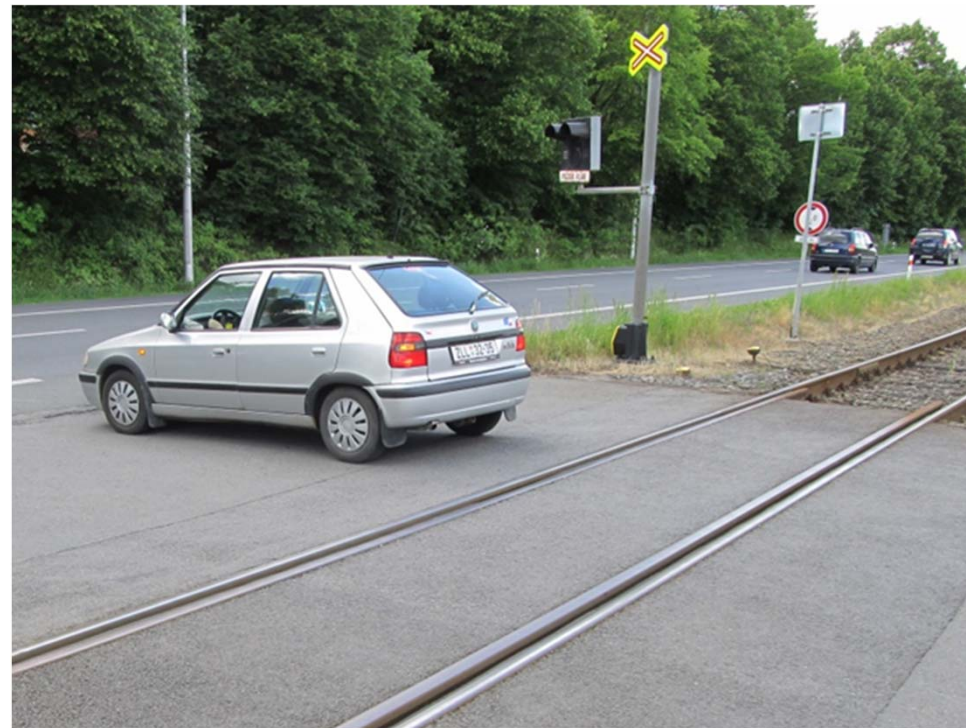
Very frequent and very serious risk factor. In most cases, solution is very hard to find. Coordination of the signal systems of the railway level crossing and neighbouring intersection proved to be efficient technical solution.
